# Study of the performance of FRP reinforcing bars subjected to extreme conditions of application

Mathieu Robert<sup>1</sup> — Patrice Cousin<sup>2</sup> — Brahim Benmokrane<sup>3</sup>

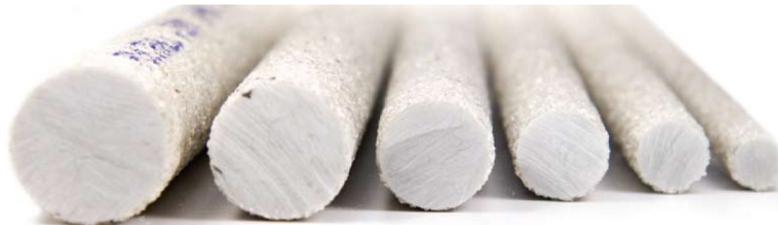
Figure 1 GFRP reinforcing bars

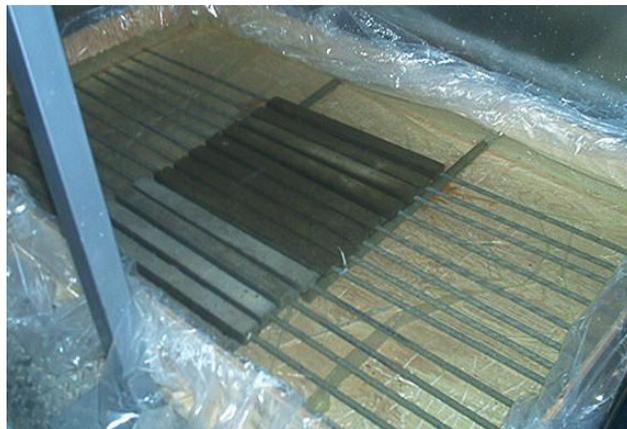
Figure 3 Wood container built for aging of the cement mortar-wrapped GFRP bar specimens

Accelerated aging of GFRP reinforcing bars embedded in concrete, used in this study, were designed to simulate an aggressive alkaline environment of saturated concrete. The embedded samples were immersed in tap water. The technique currently used is believed to be representative of the real life situation. Indeed, the pH of the solution surrounding the bars is a result of the absorption of water by the concrete, thus allowing the liberation of the alkaline ions of the concrete directly in the bars environment. The aging was performed by immersing the mortar-wrapped GFRP bars in a wood container specially manufactured for the study. Figure 3 shows the containers that were tightly closed with a polyethylene film on their inner surfaces. A polyethylene sheet was also placed on top of the wood containers to avoid excessive evaporation of water during the conditioning. Bars were spaced from each other and from the bottom of the container to allow the free circulation of the solution between and around the GFRP bars. Furthermore, the water level was kept constant throughout the study to avoid a pH increase which could be due to a water level decrease and a significant increase of the concentration of the alkaline ions in the solution. The temperatures of immersion were chosen to accelerate the degradation effect of aging; however, they were not too high to produce any thermal degradation mechanisms. The specimens were completely immersed at three different temperatures (23, 40 and 50°C) and were removed from the water after four different periods of time (60, 120, 180 and 240 days). After each period, usually six GFRP bars were removed from the water, tested under tension to compare their tensile strength retention values to those of the reference specimens. Microstructural and physical analysis were also performed after immersion.

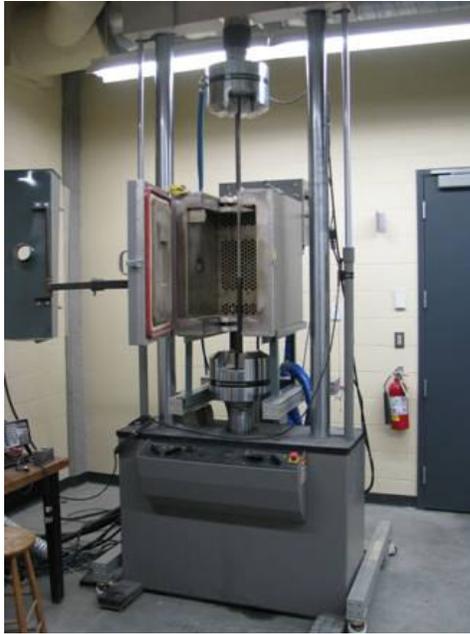
Figure 4 Test setup for tensile tests at controlled temperature

Properties of GFRP bars submitted to extreme temperatures were measured. All GFRP bar specimens were tested under extreme temperature conditions using a MTS environmental chamber cooled by liquid nitrogen (Figure 2). Sub-zero temperatures equal to -100°, -80°, -60°, -40°, -20° and also 0°C were chosen to simulate the effect of Nordic climate on GFRP bars. The temperatures below -60 °C were used to amplify the effects of temperature on mechanical and microstructural behaviour of the FRP materials. Elevated temperatures equal to 50°, 100°, 150°, 200°, 250° and 325°C were chosen to simulate short-term environmental conditions in the case of fire. All the tests were conducted using a steady-state temperature (heat then load) regime. To be sure that the temperature at the core of the GFRP bars reached the desired temperature, an extra GFRP bar was kept in the same conditions and its core temperature was monitored using a thermocouple that was inserted in the core of this bar. When the desired temperature was reached (from the thermocouple reading), it was kept constant and the GFRP specimens were tested at that temperature.
